Cork
County Council
Comhairle Contae Chorcaí

Cork to Kinsale Greenway Chetwynd and Halfway Viaducts - Inspection and Assessment

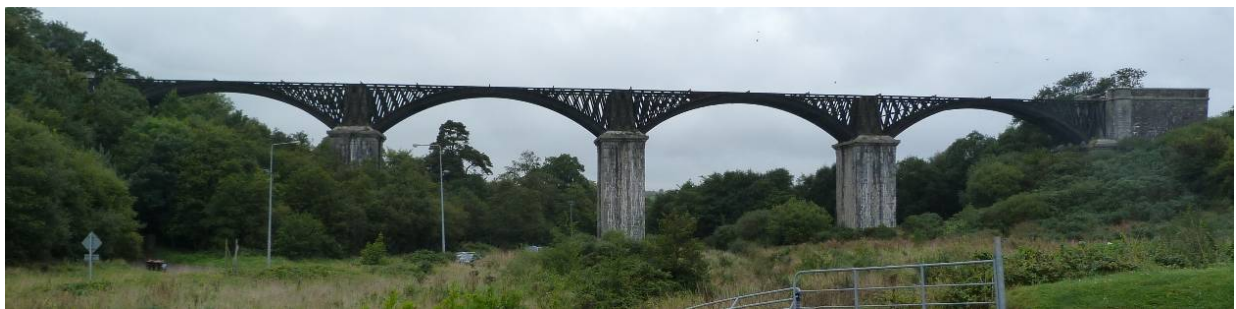
Figure 1.1: Chetwynd Viaduct

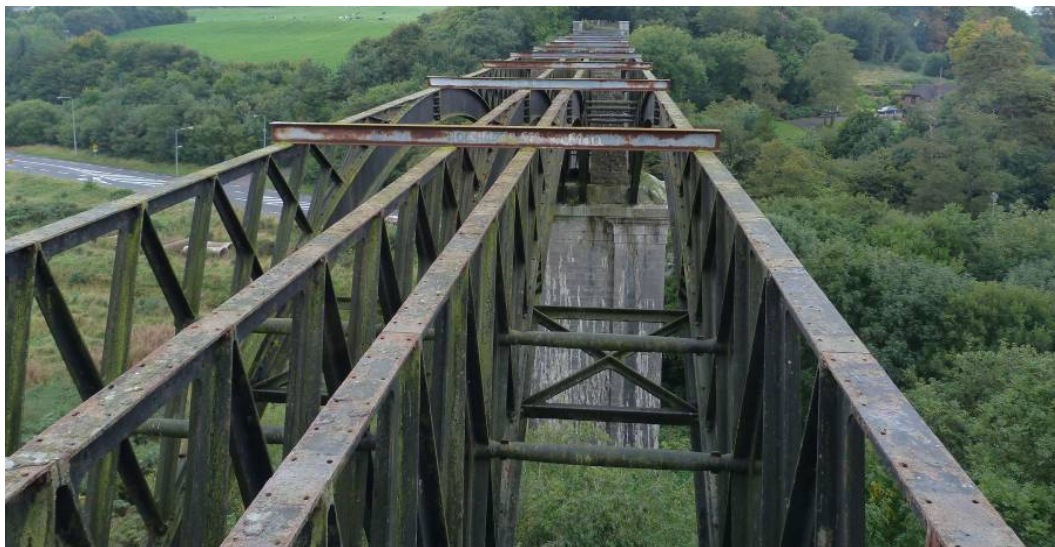
Figure 2.4: Current condition of bridge surface

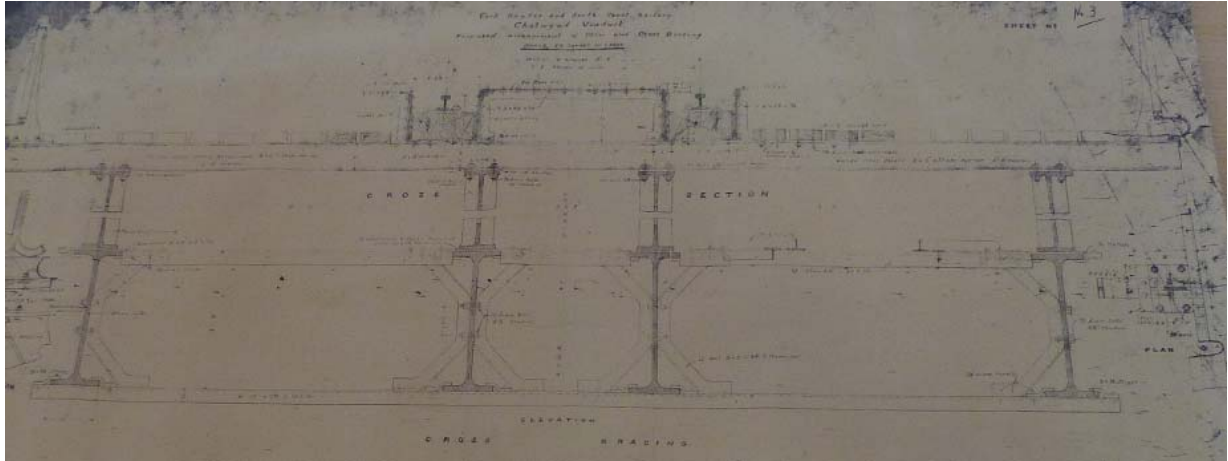
Figure 2.5: Construction drawing of bridge deck

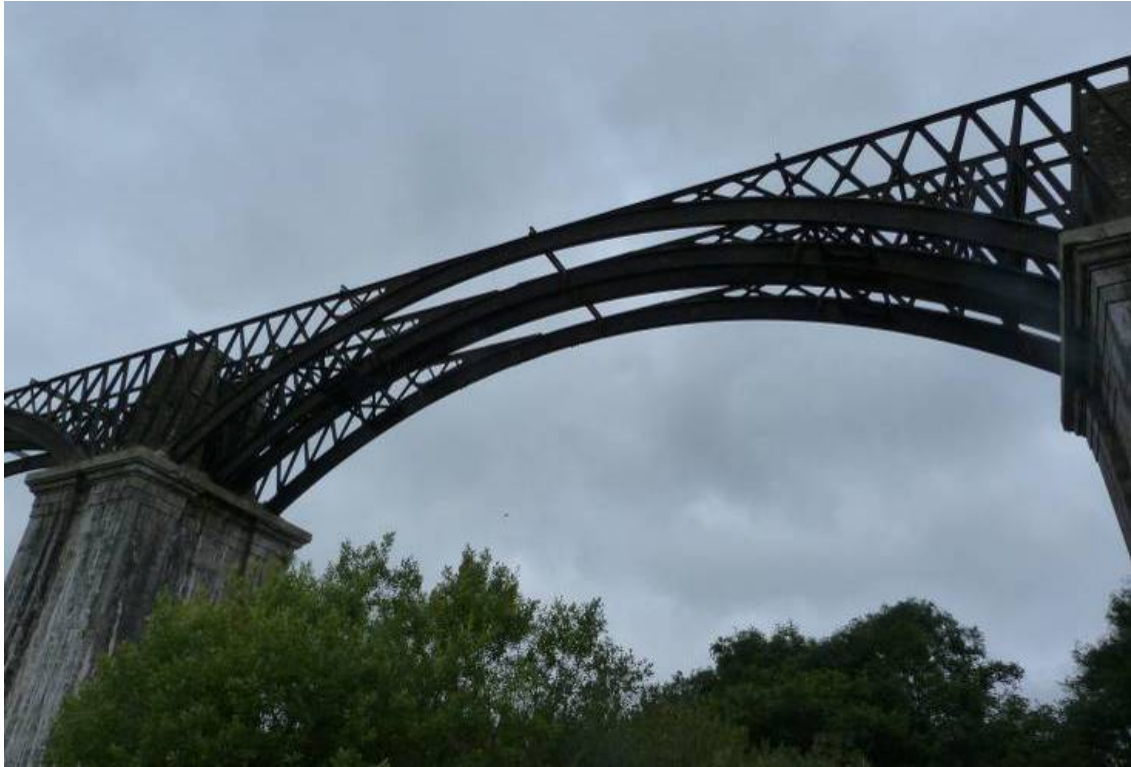
Figure 2.7: Cast iron arched ribs

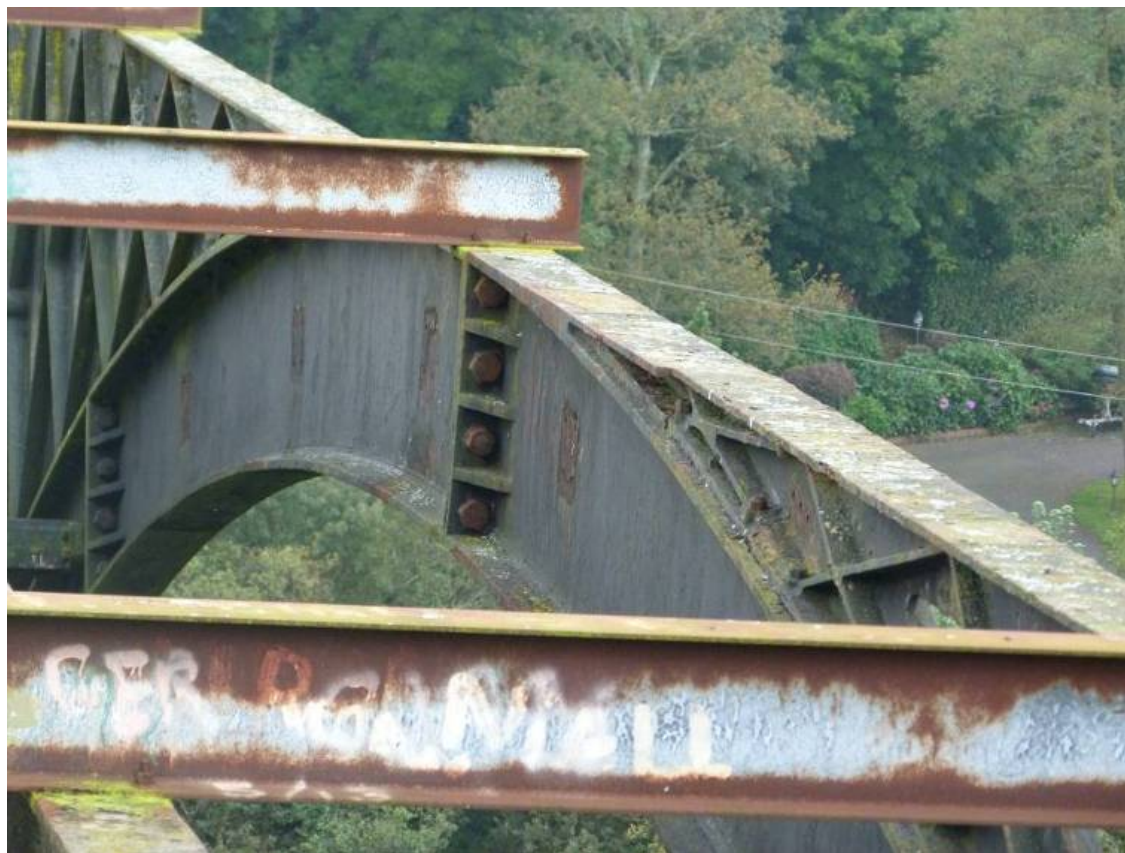
Figure 2.8: In-line bolted splice connections (note localised failure of paint system)

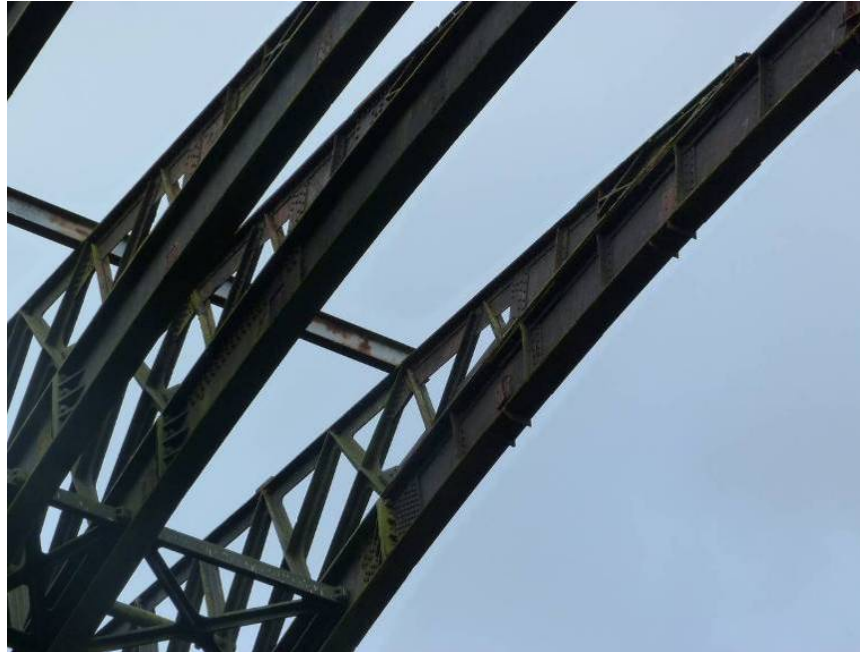
Figure 2.9: Repaired sections of arch and spandrel wall in span 3 (solid spandrel infill plates, additional stiffeners and gusset plates)

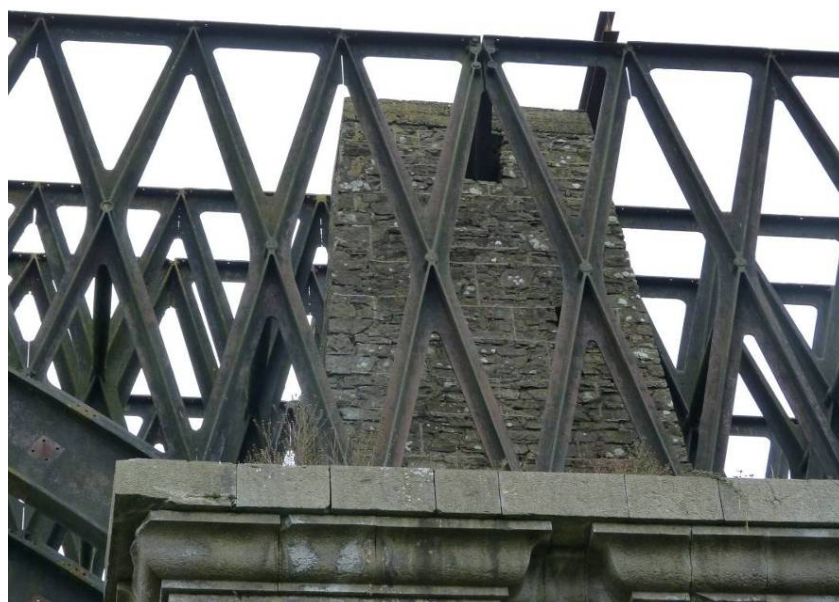
Figure 2.10: Prefabricated cast iron latticed spandrel walls at pier

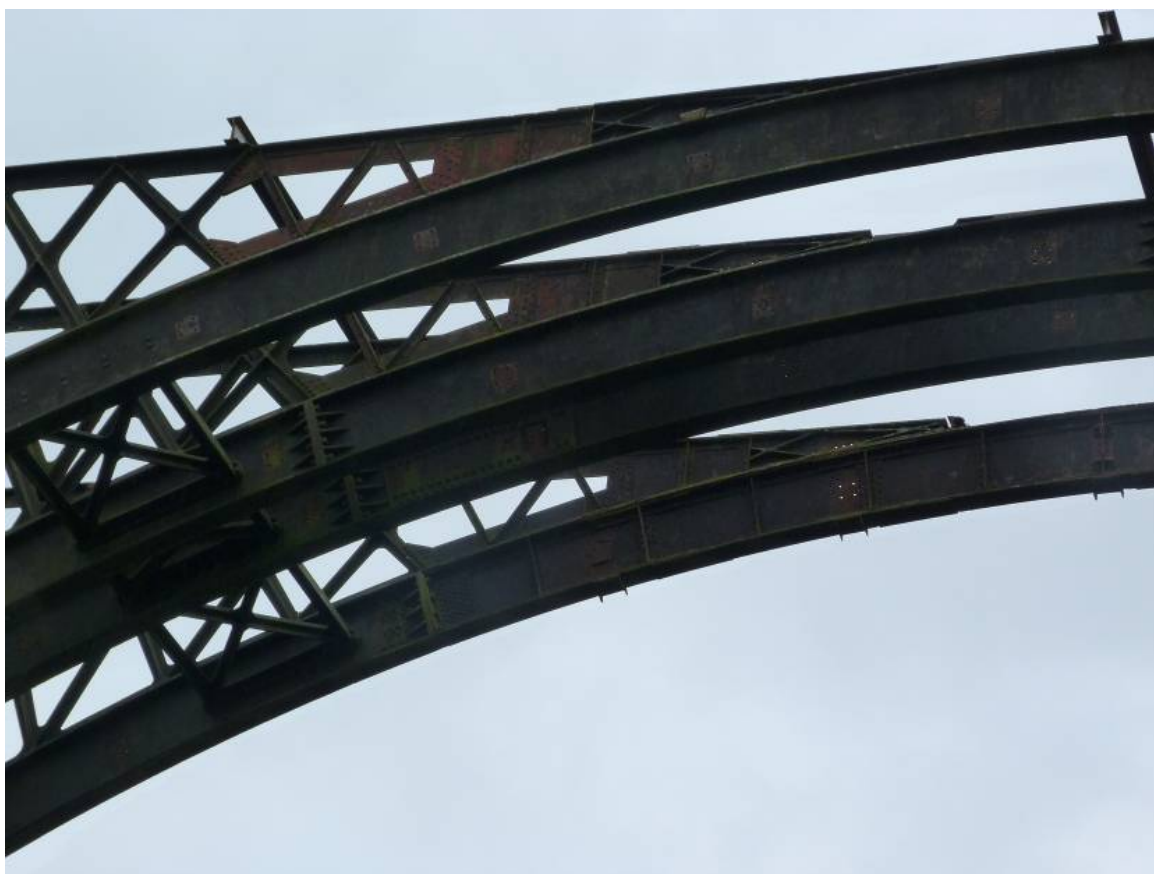
Figure 2.12: Repairs to spandrel walls in span 3

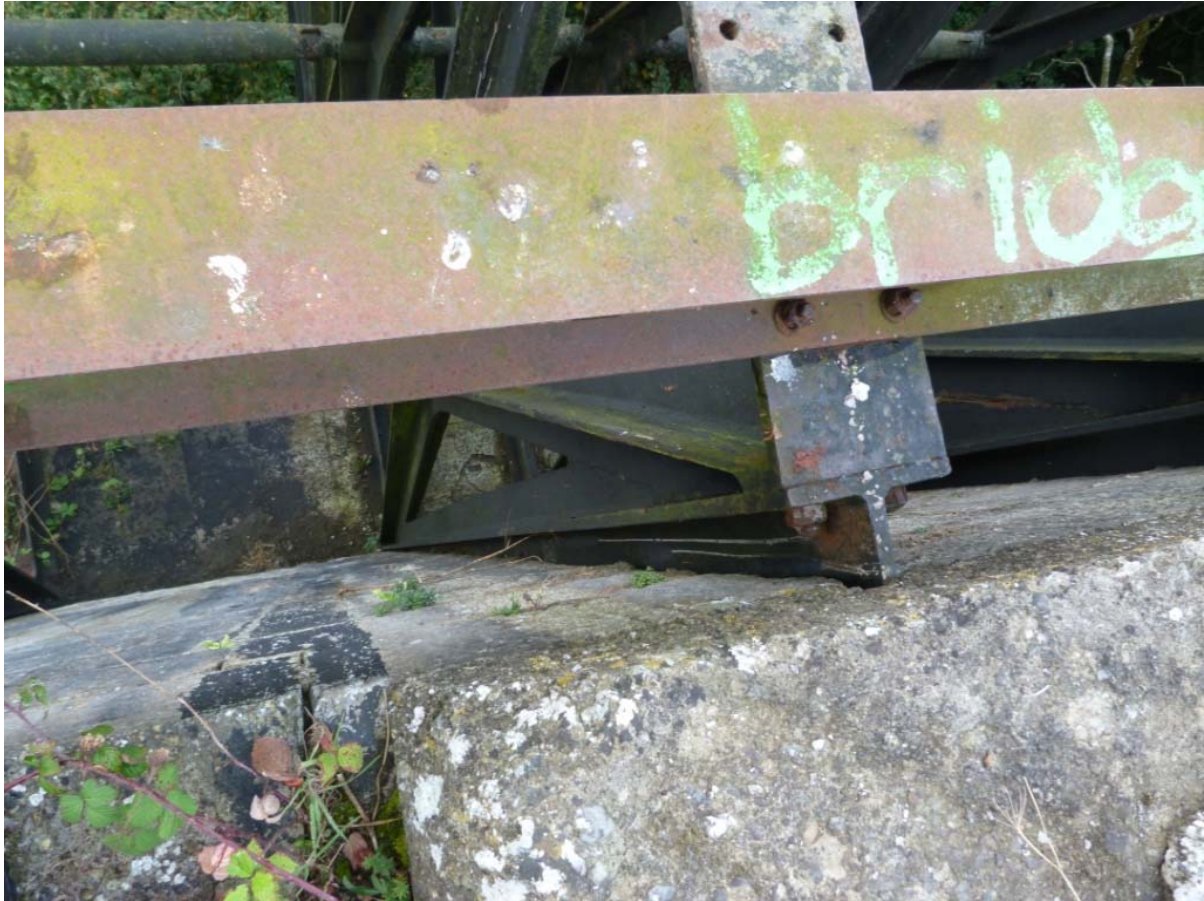
Figure 2.13: Recessed spandrel wall expansion joint detail at abutments

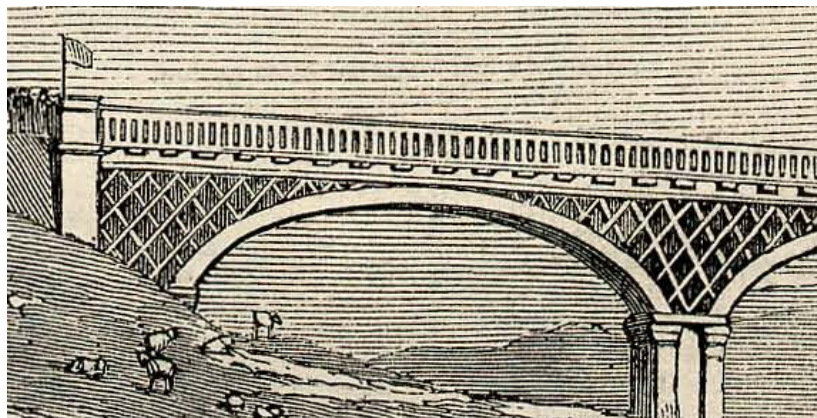
Figure 2.14: Bridge parapet circa 1851 (Illustrated London News, 1851)

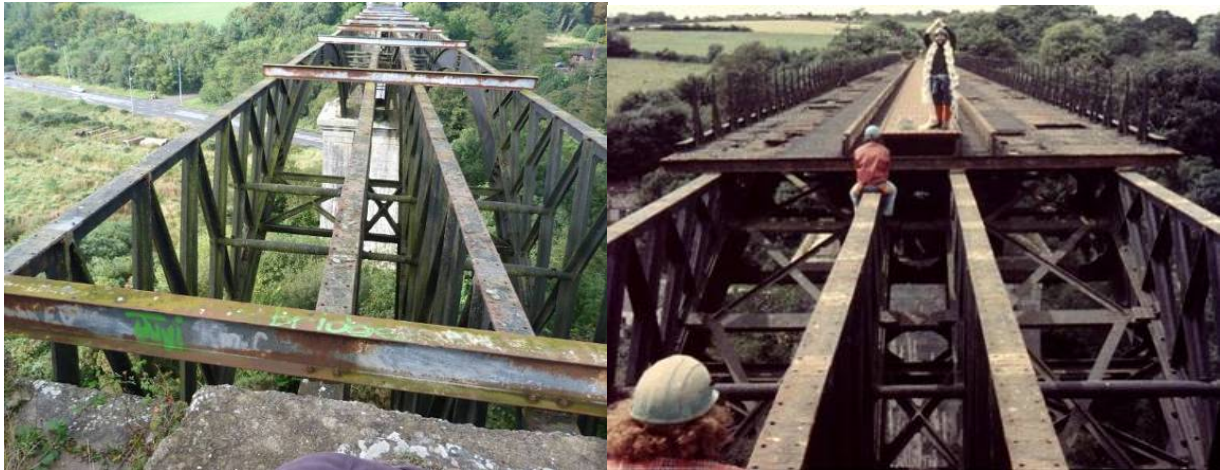
Figure 2.18: Existing condition of bracing members (left) and previous bracing members (right) during deck removal (circa 1970), note a large proportion of lateral X-shaped cast iron bracing has been removed

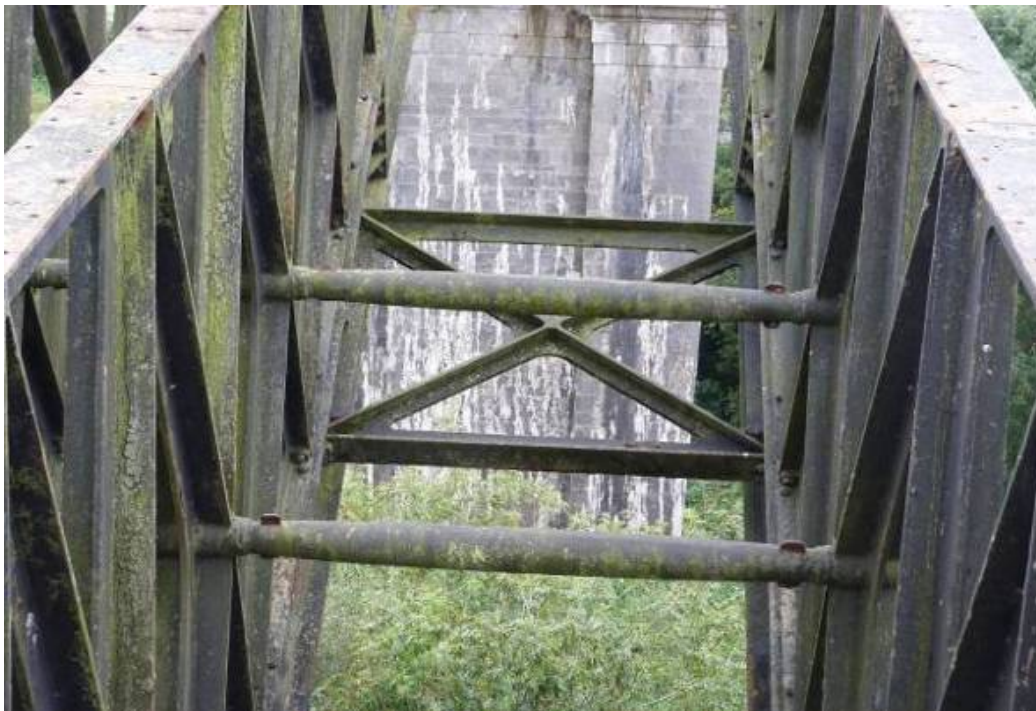
Figure 2.19: X-shaped cast iron bracing and transverse wrought iron tie rods

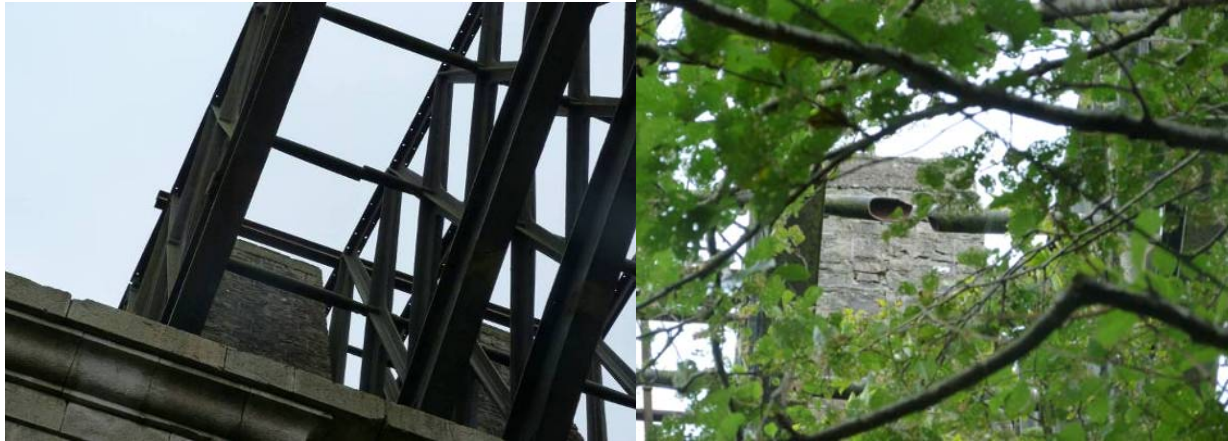
Figure 2.20: Failed wrought iron tie rods

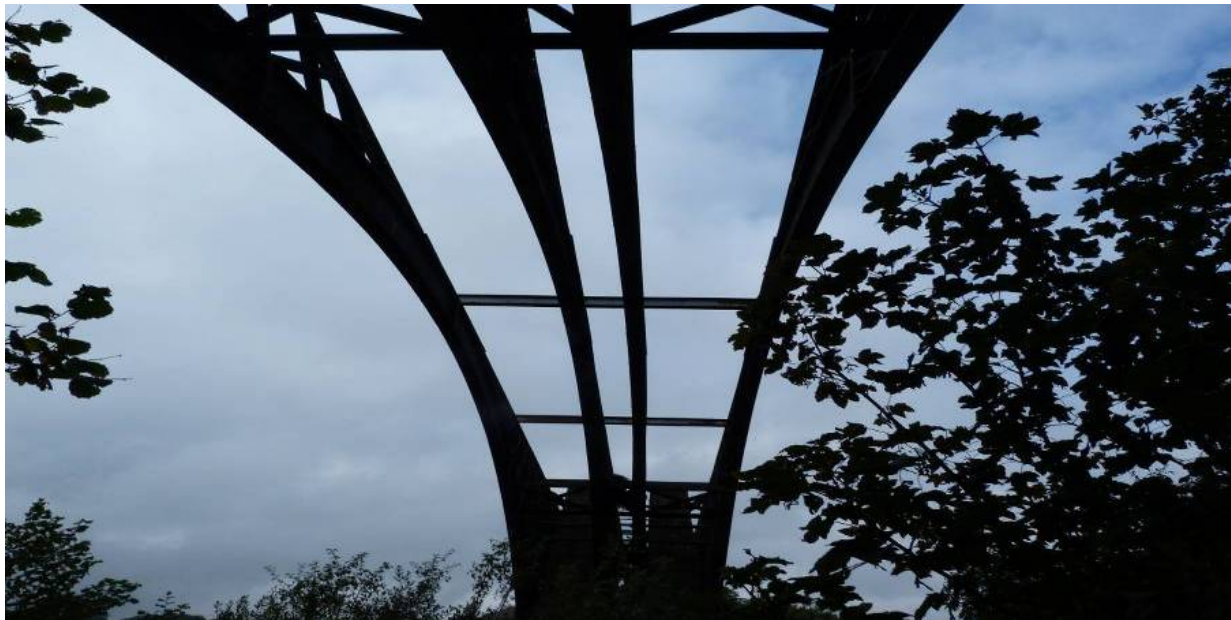
Figure 2.21: Underside of bridge deck (note absence of lateral bracing along length of arch ribs)

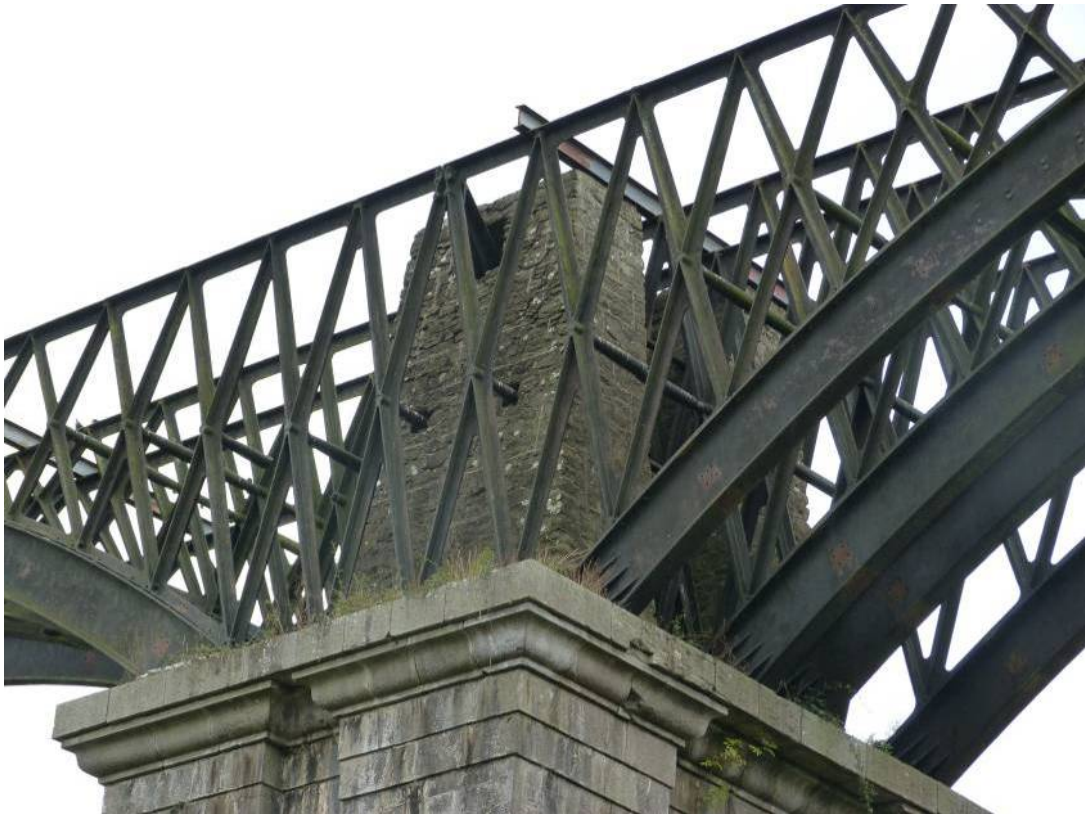
Figure 2.22: Vegetation growth on top of pier

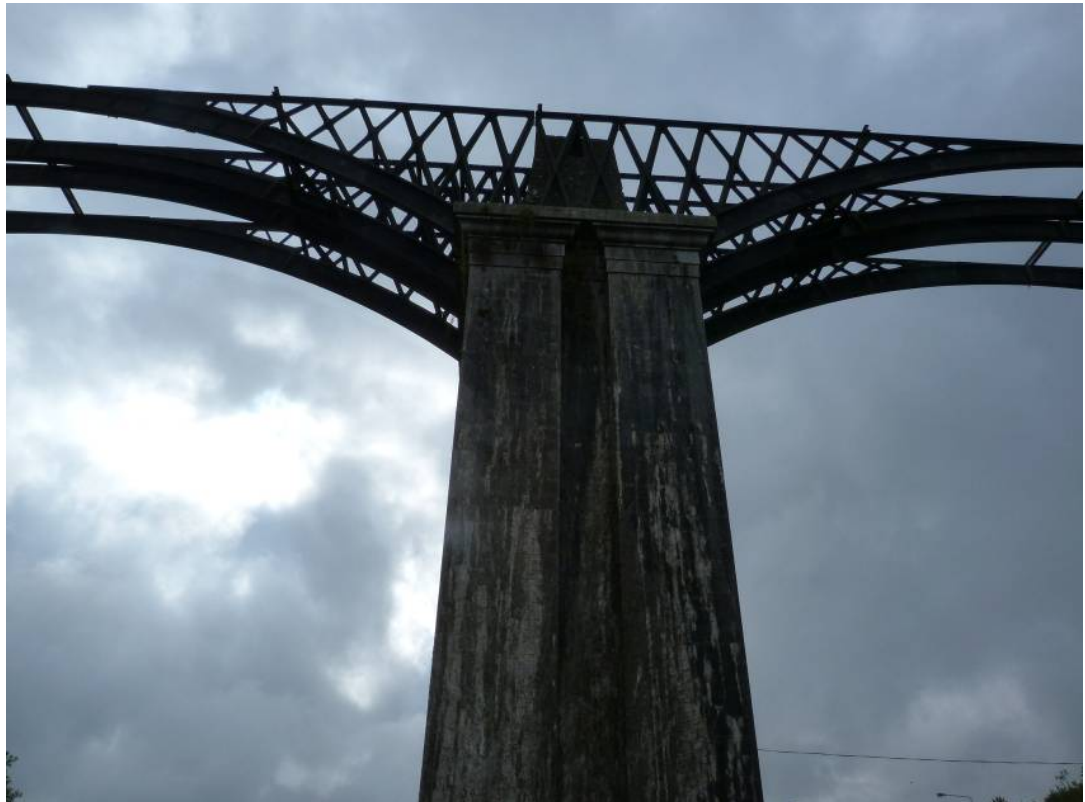
Figure 2.23: Staining on pier

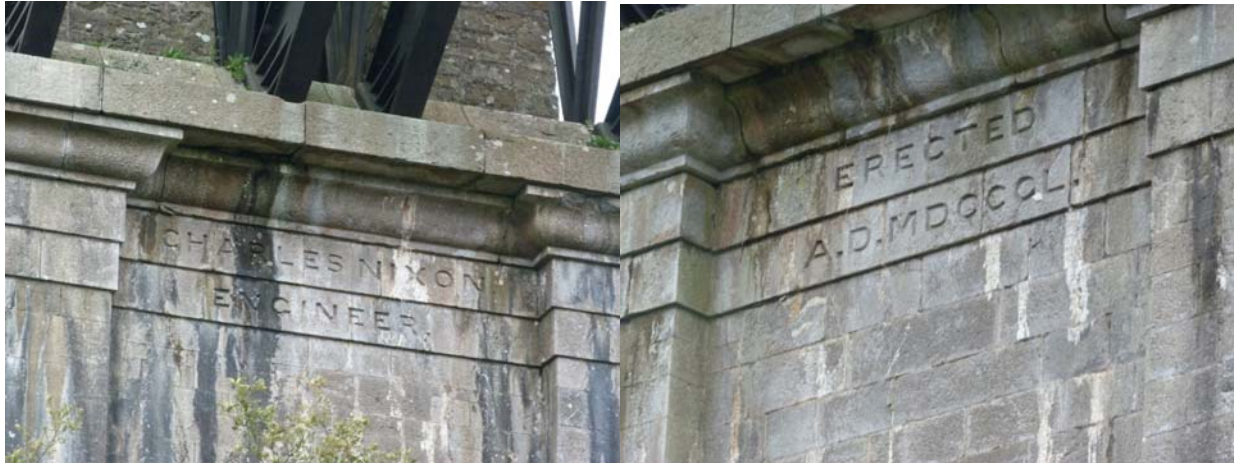
Figure 2.24: Details of Engineer and Contractor inscribed on piers

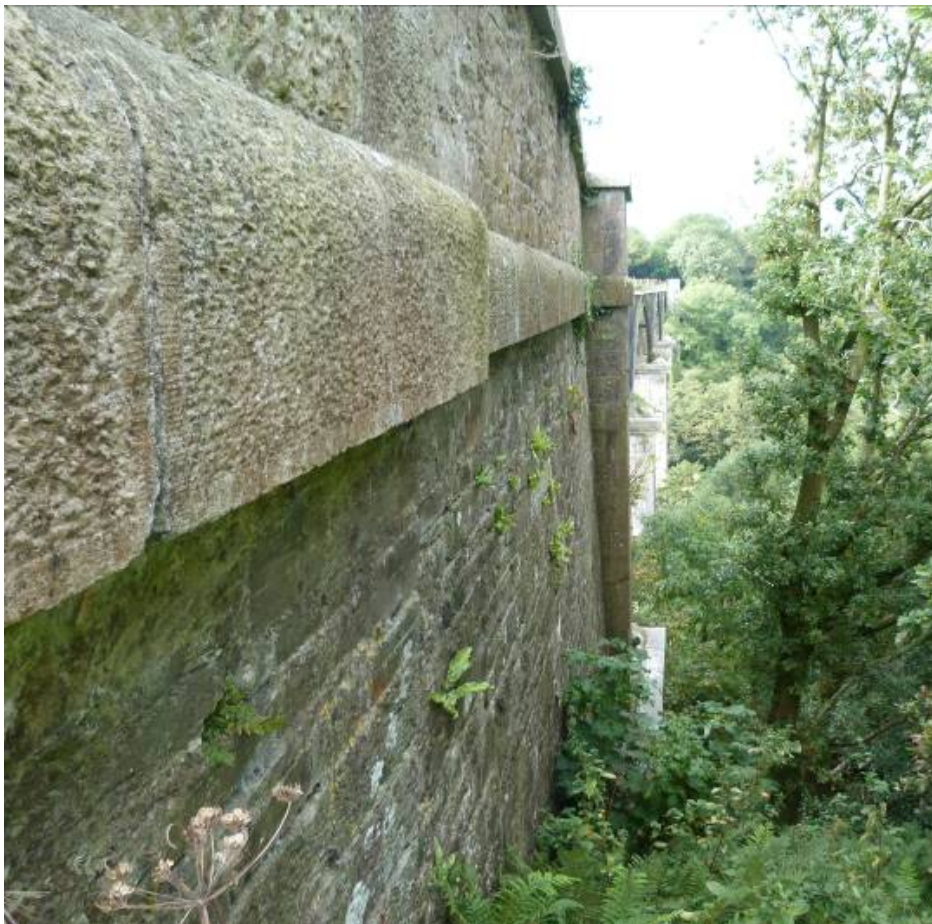
Figure 2.25: Minor vegetation growth from abutment

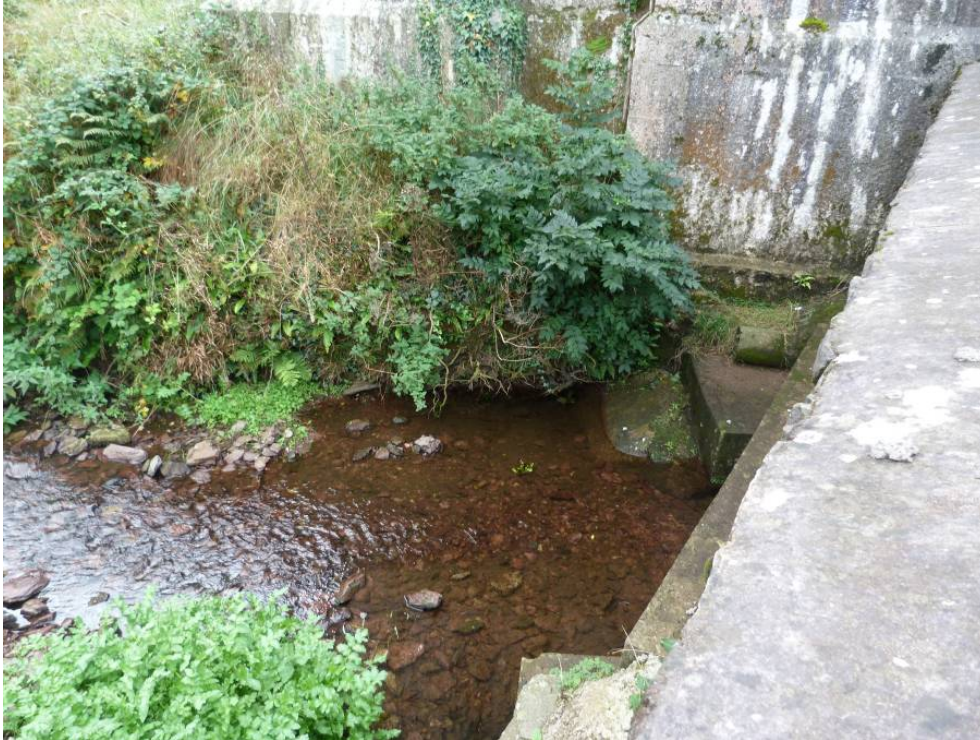
Figure 2.28: Localised erosion to the banks of the watercourse at the pier base

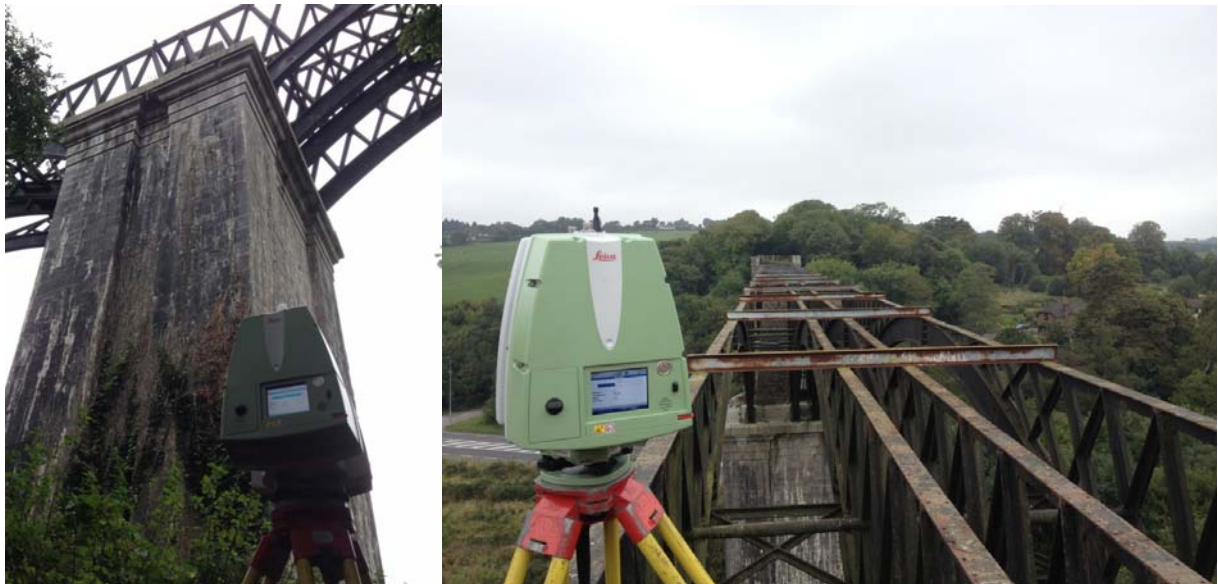
Figure 2.29: 3D laser scanning of Chetwynd Viaduct in operation

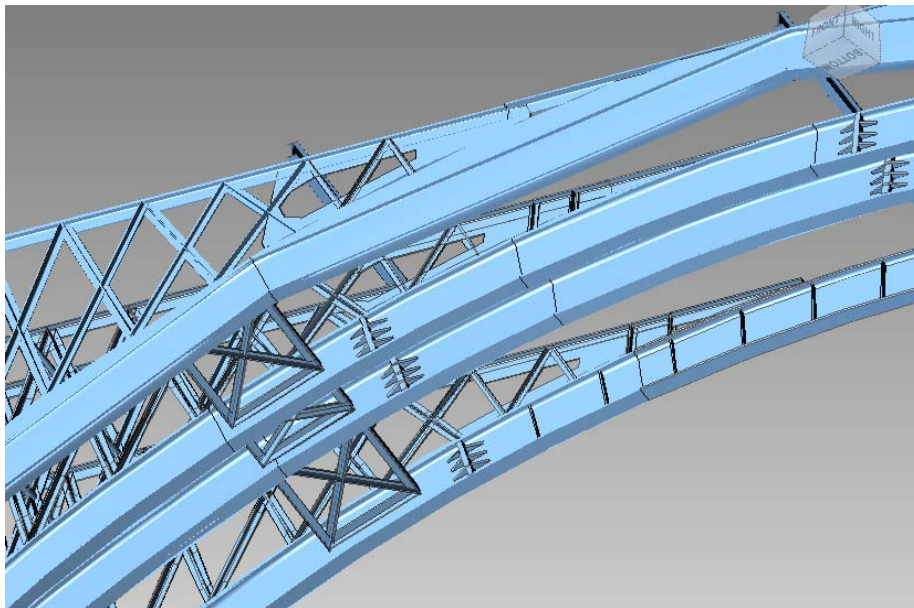
Figure 2.32: Fleshed 3D scan showing details of the repaired section on span 3

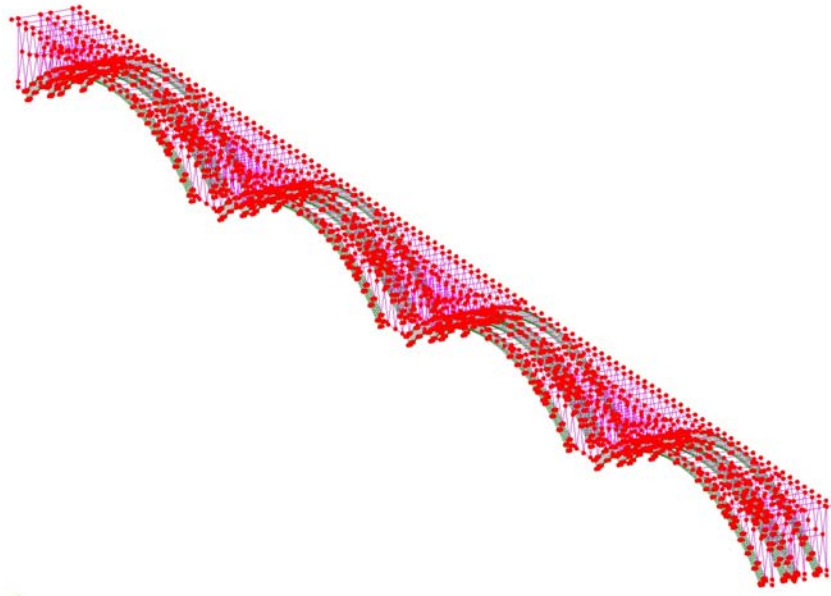
Figure 2.33: 3D finite element model of Chetwynd Viaduct

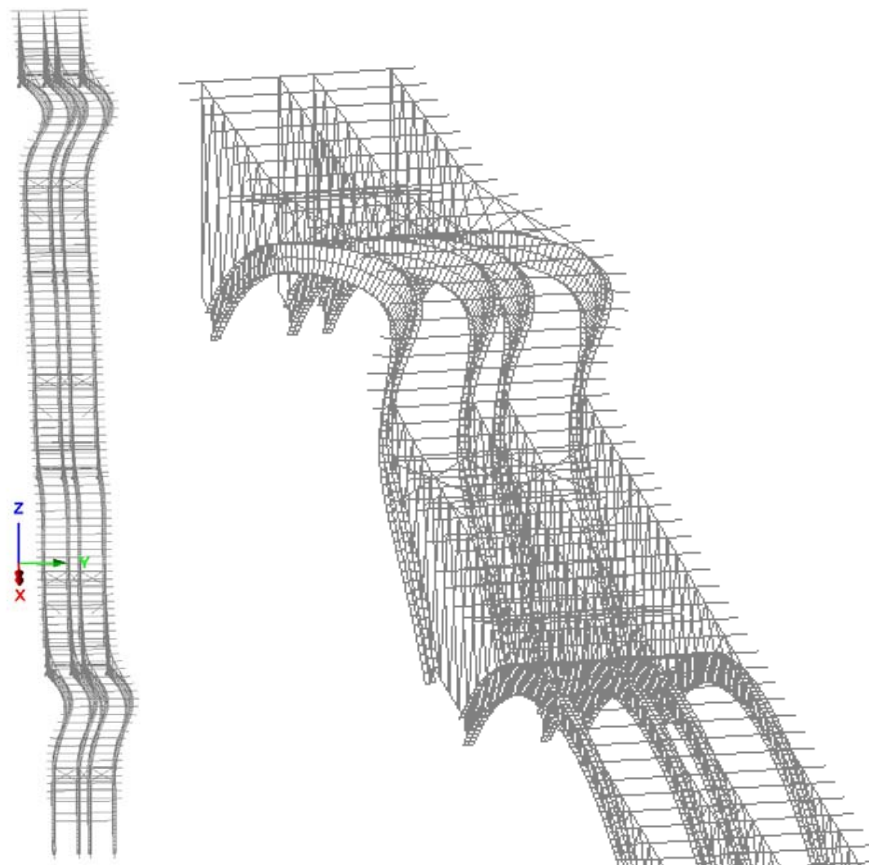
Figure 2.36: Observed mode of out-of-plane buckling of arch ribs in absence of sufficient lateral bracing

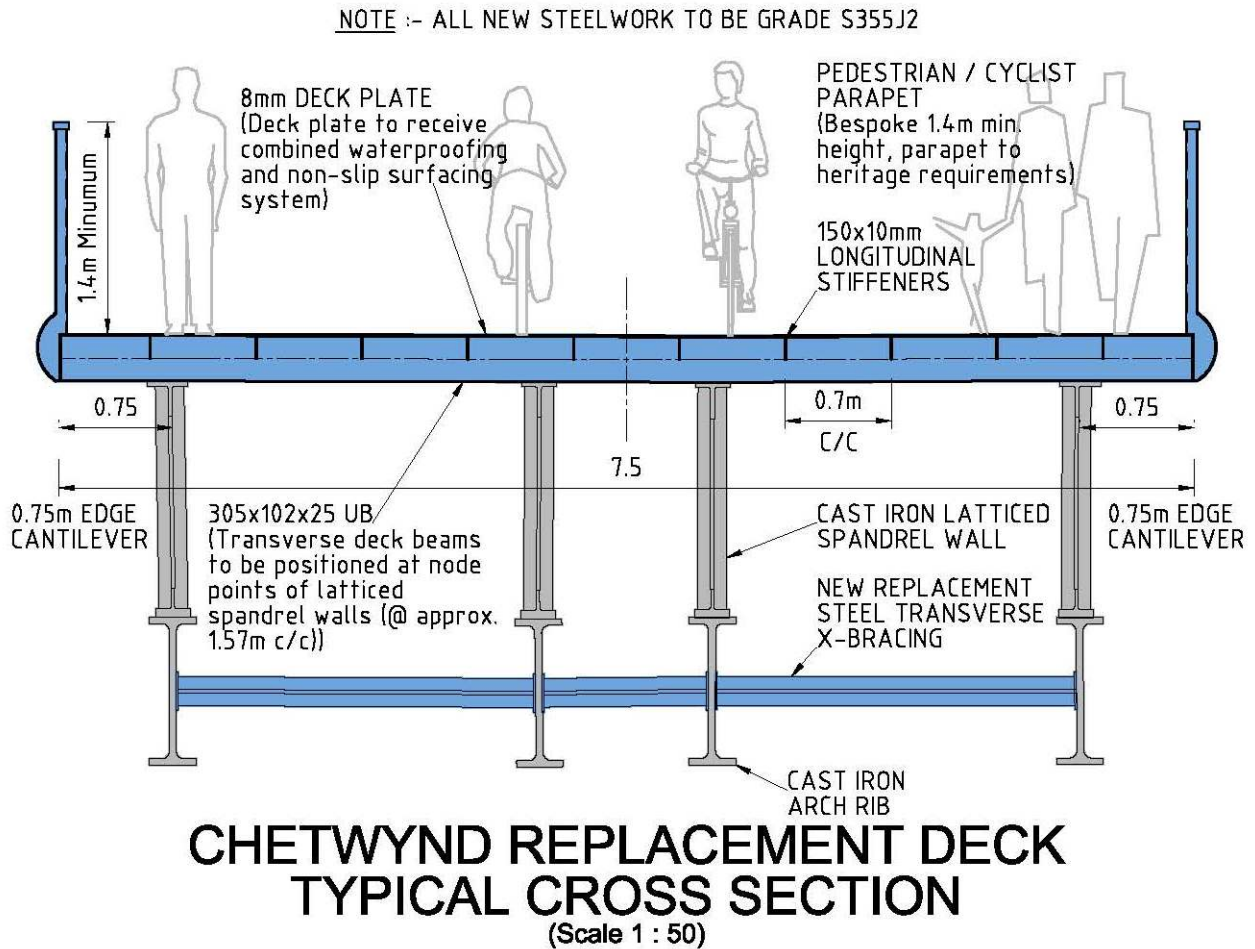
Figure 2.37: Preliminary structural form of deck replacement (existing cast iron shown in grey, new steelwork shown in blue)

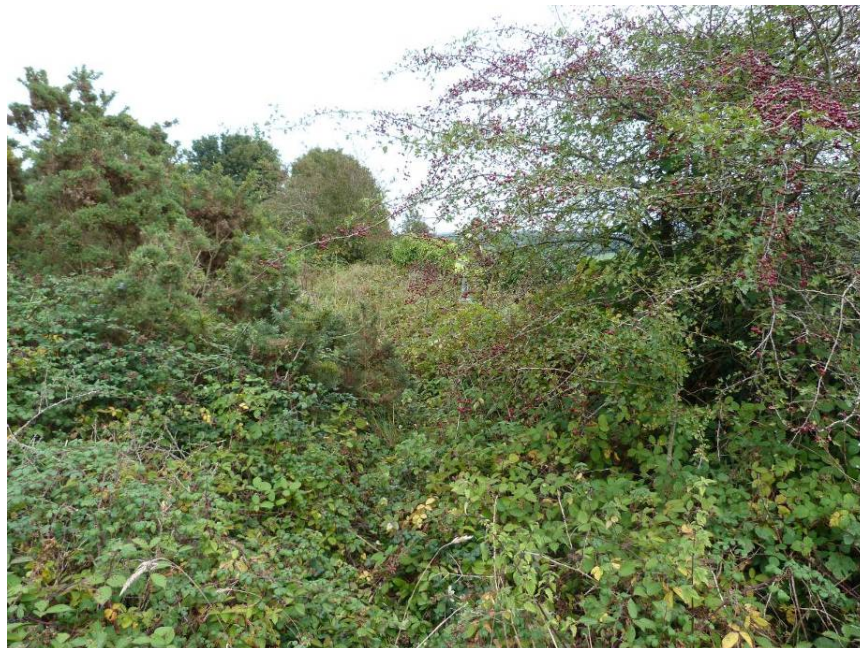
Figure 3.2: Dense vegetation growth on the bridge deck

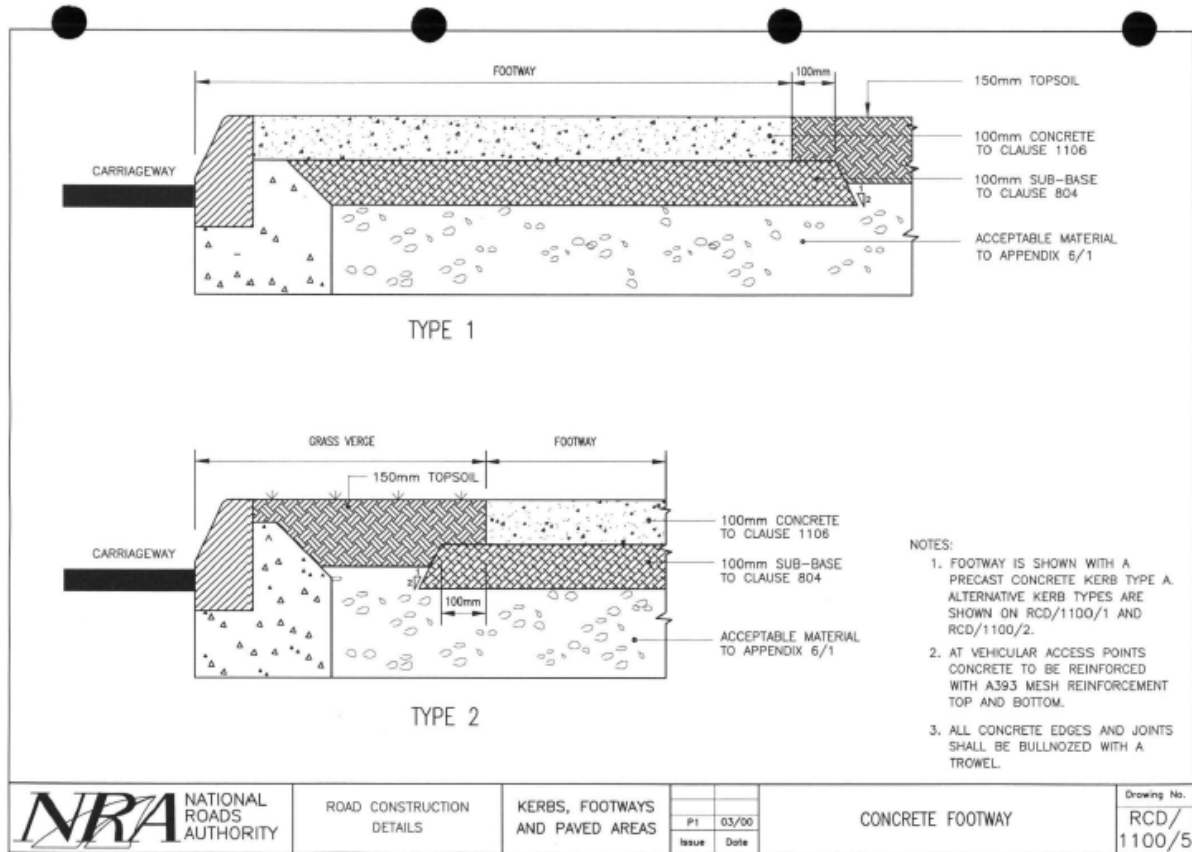
Figure 3.3: Recommended concrete pavement to bridge deck

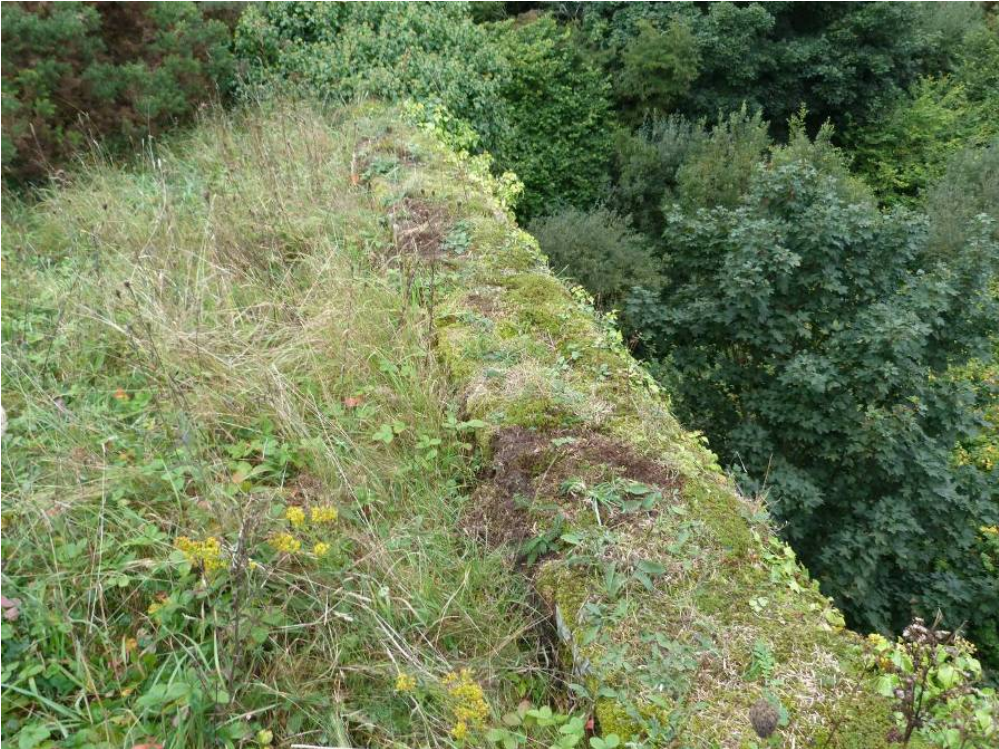
Figure 3.4: Northern masonry parapet wall

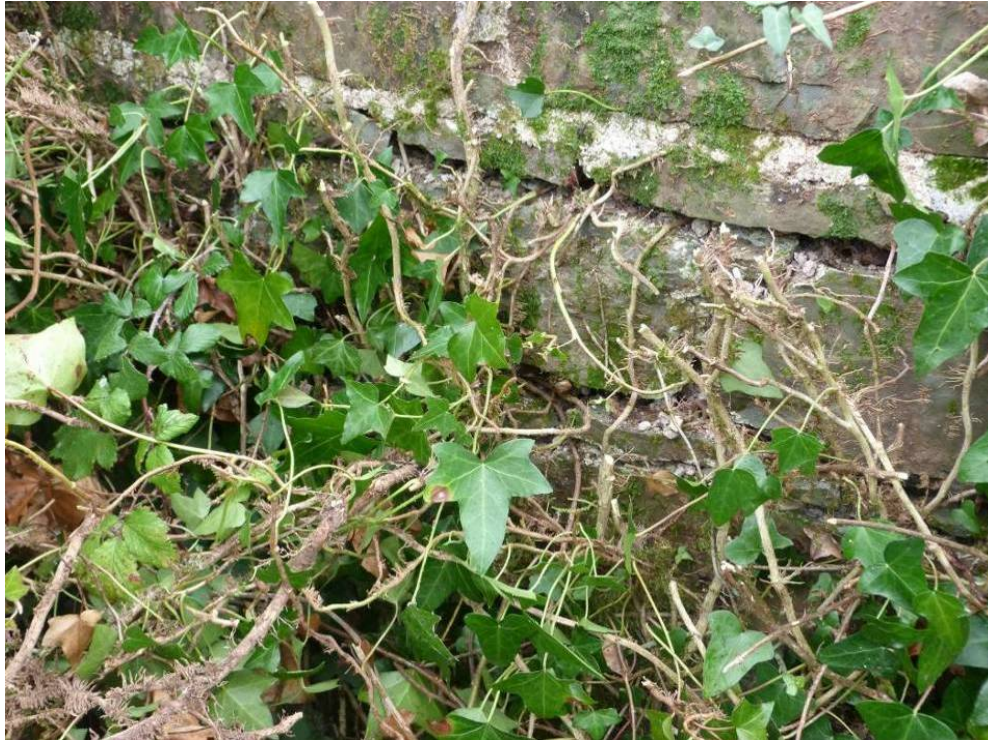
Figure 3.6: Evidence of damage to masonry caused by vegetation on southern parapet

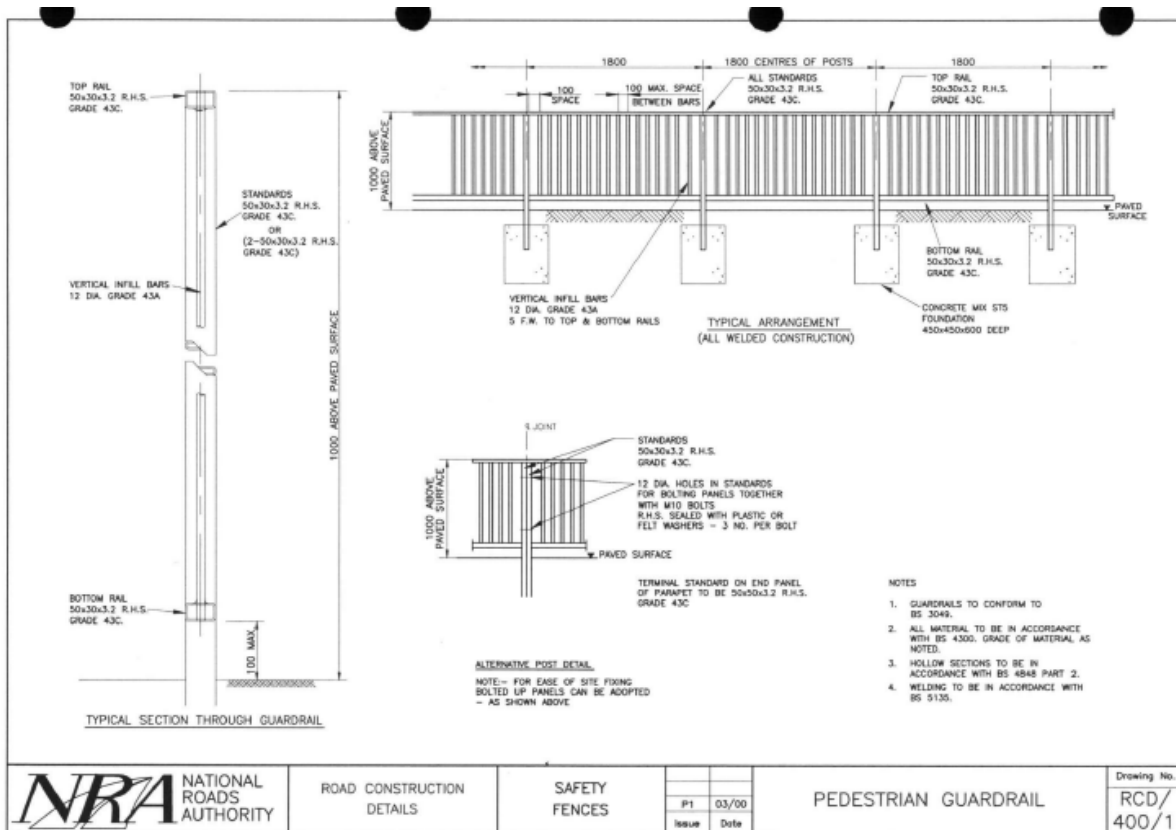
Figure 3.7: Bridge parapet details (note parapet to be a minimum of 1.4m high)

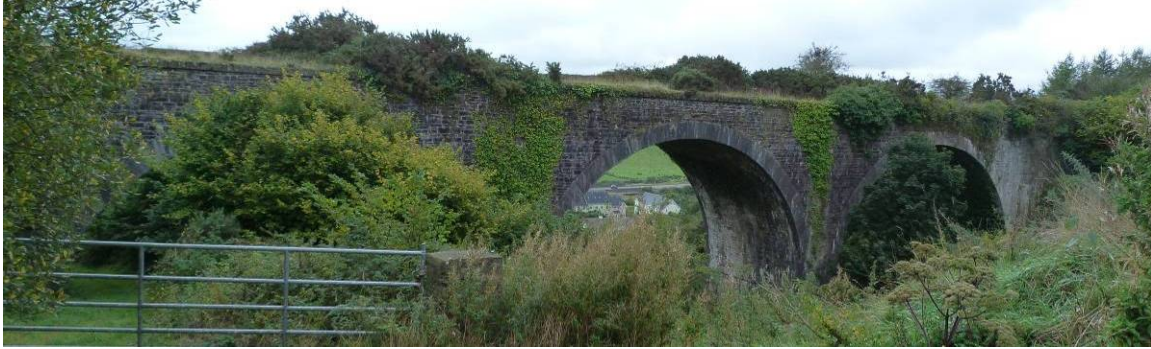
Figure 3.8: Northern elevation showing vegetation growth

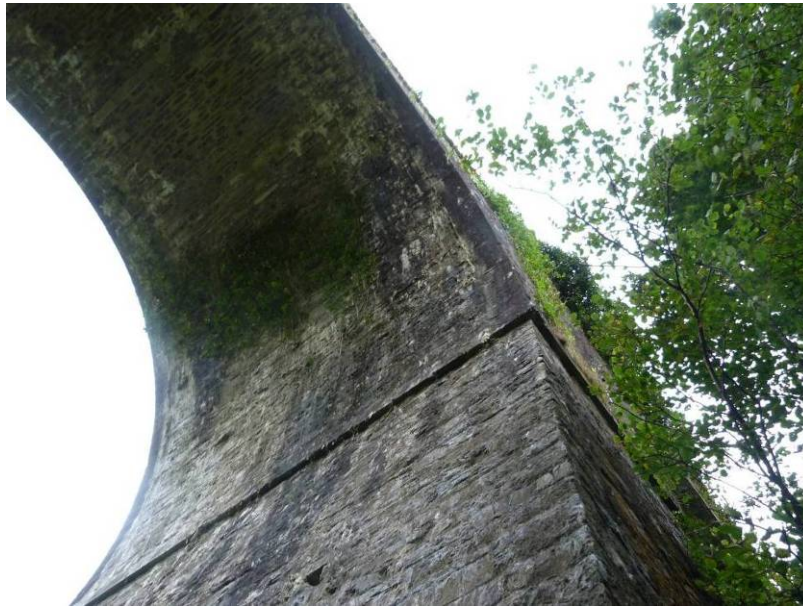
Figure 3.11: Arch barrel soffit (note water penetration)

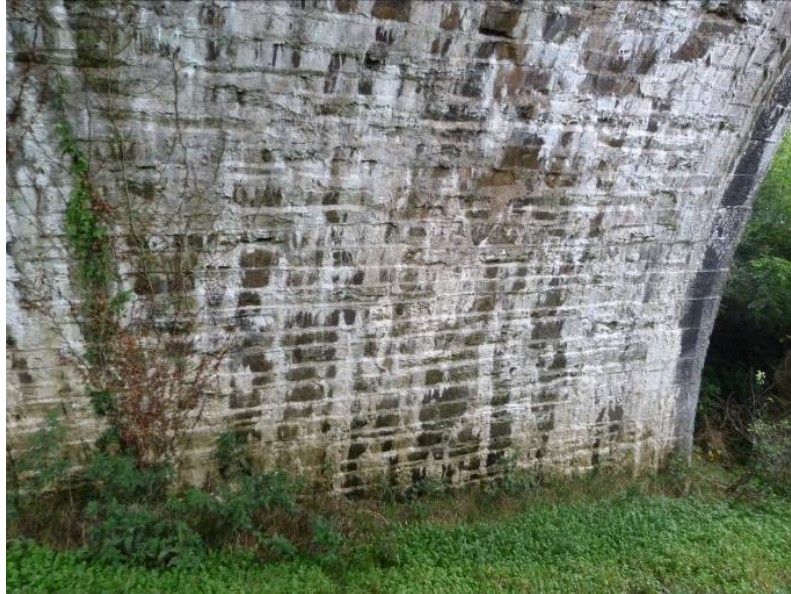
Figure 3.13: Staining to eastern abutment
