Cork
County Council
Comhairle Contae Chorcaí

Cork to Kinsale Greenway Chetwynd and Halfway Viaducts - Inspection and Assessment

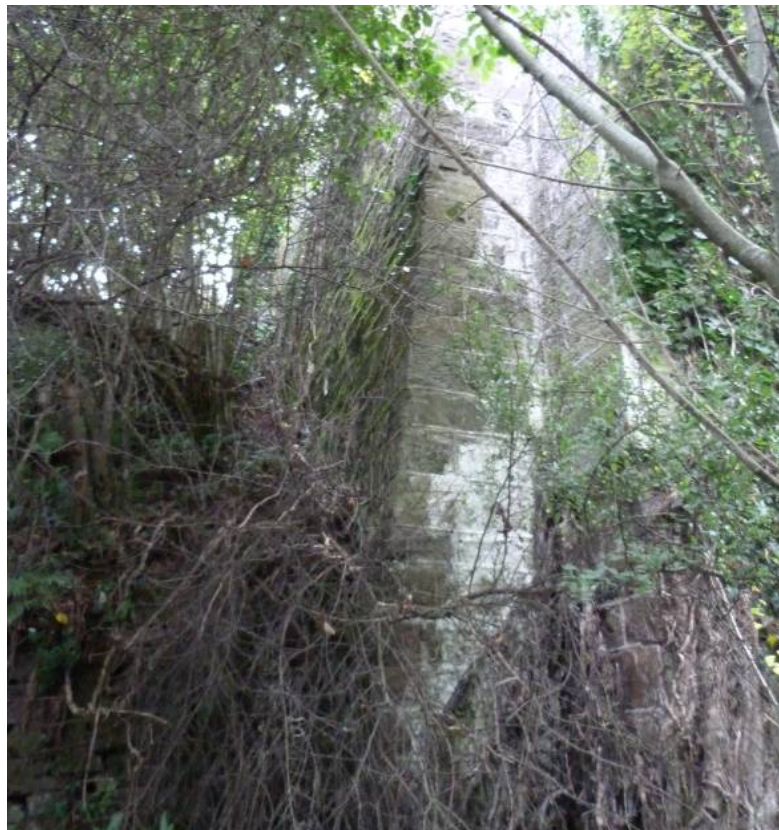
Figure 3.14: Vegetation growth on western abutment

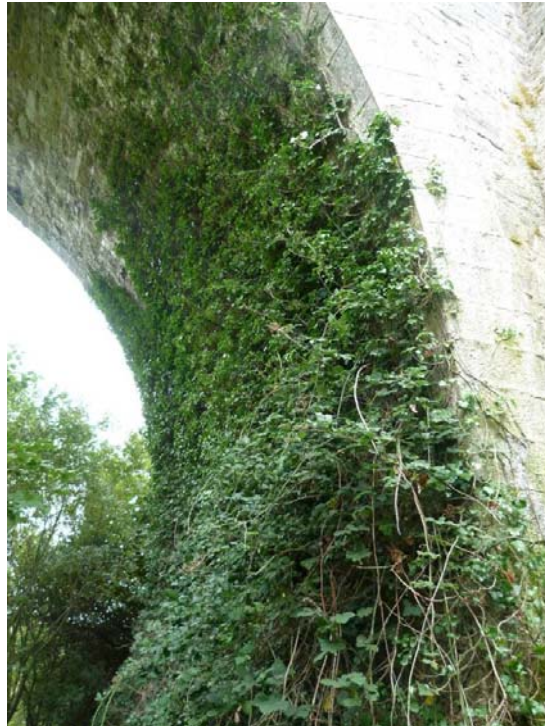
Figure 3.16: Vegetation growth on pier

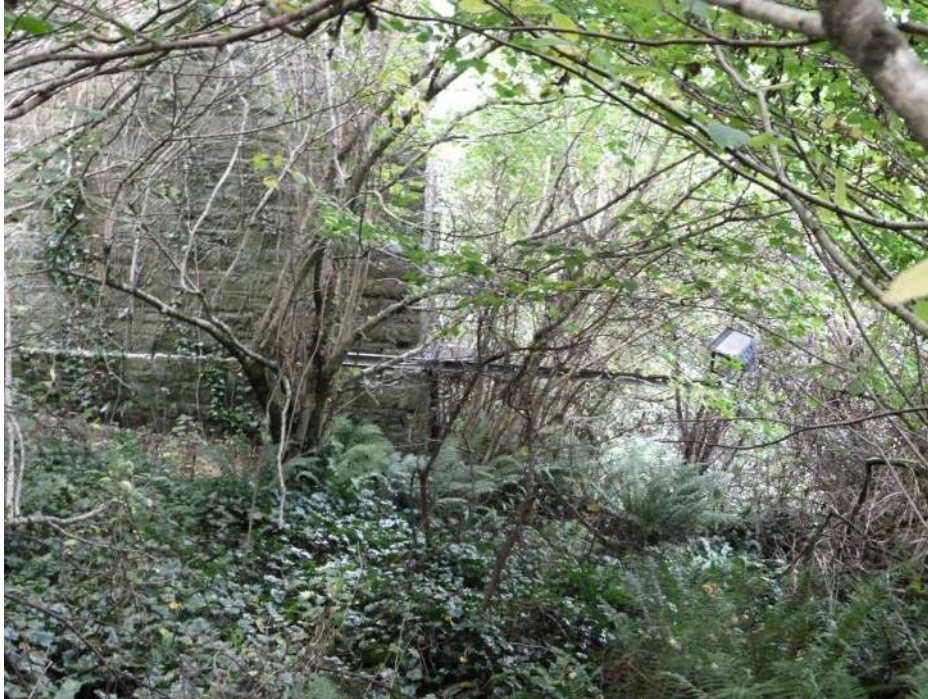
Figure 3.19: Bridge up-lighting attached to pier
